Manhole Inspection Summary

Manhole # S37QQ_004MH

Insp Date: **1/17/07 8:49 AM**

Location Address: **600 LOCH RAVEN RD**

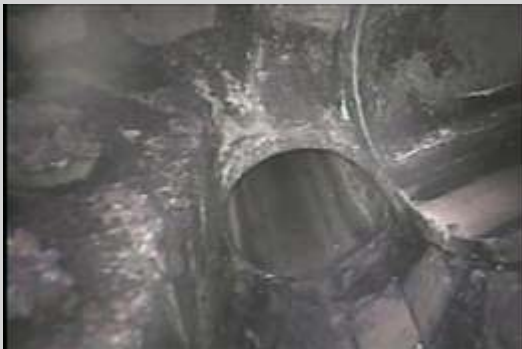
6 in. Circular Gravity Sewer Pipe In @ 5 O'Clock

Pipe Material: **Clay** ☐ Pipe Lined

Invert Depth: **7.16** (ft.) Flow Characteristics: **Slow**

Deposits: ☒ **None** ☐ Mud ☐ Sludge ☐ Debris ☐ Grease

Infiltration: **None** Pipe Seal Cond: **Unknown**

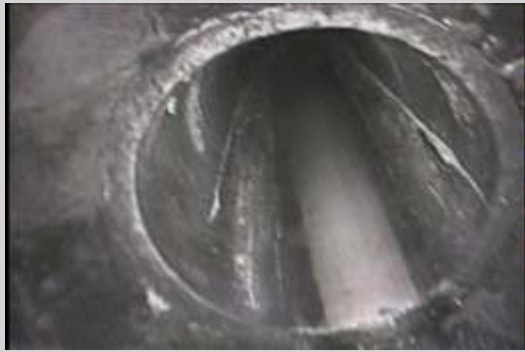
8 in. Circular Gravity Sewer

Pipe Material: **Clay**

Infiltration: **None**
